# Post-Mining Reclamation Plan

**Mountain Ash Limited Partnership Summit Pit**

SLR Project No: 212.06650.00006

April 2021

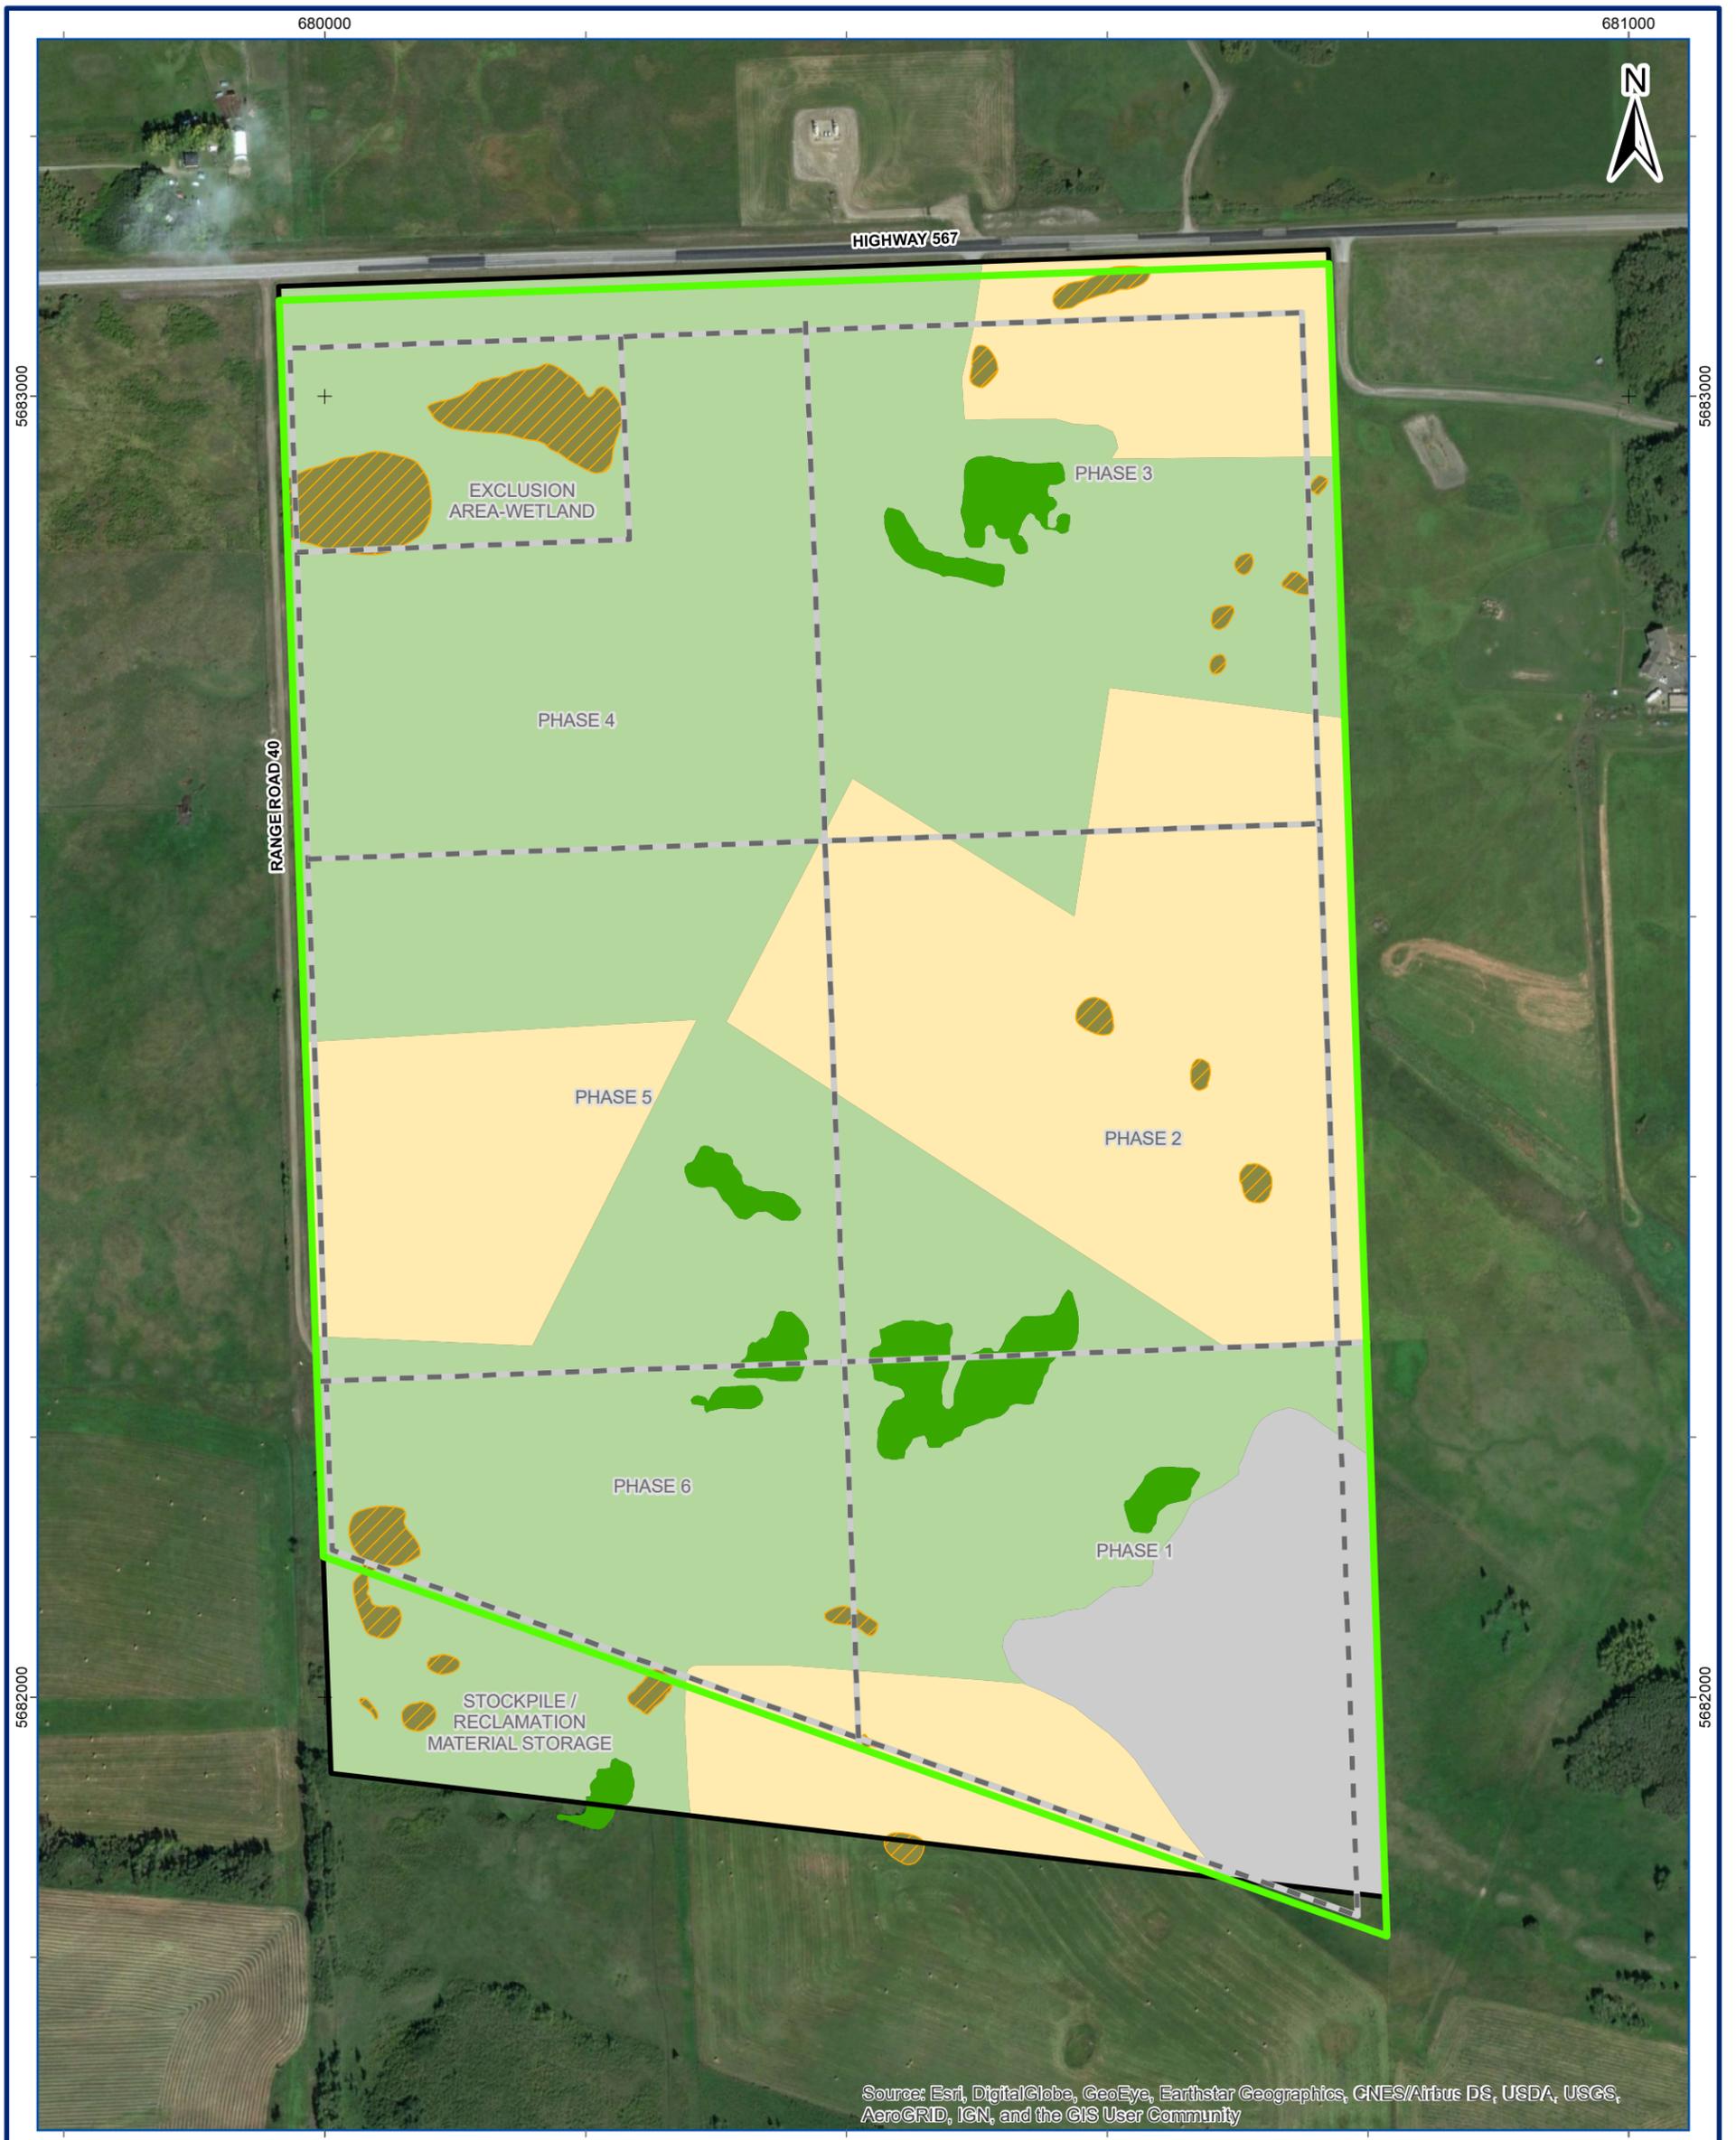
**SOILS AND VEGETATION**

Onsite vegetation consisted mostly of hayland / tame pasture species dominated by wheatgrass, brome species, alfalfa, and timothy. Treed areas, marsh areas and native pasture was also present (Figure 2). A detailed vegetation list is provided in Appendix C of the Biophysical Impact Assessment Report.

1. Soil within the rest of the Project Area is classified as Orthic Black Chernozem of the Dunvargan soil series. This map is for conceptual purposes only and should not be used for navigational purposes.

It was determined that underlying parent material in the Project area is moderately to strongly calcareous, mixed Continental and Cordilleran till (Alberta Soil Information Centre 2021). Fertile loam to clay loam Orthic Black Chernozemic soils are extensive, with Gleysolic soils present in poorly drained and lower slope positions expected at the Project (Alberta Agriculture and Forestry 2021). The AGRASID information was consistent with SLR field assessment conducted on June 2019. The Dunvargan soil series, a fertile, well-drained Orthic Black Chernozem formed on glacial till parent material, was identified across the majority of the Project area, with the gleyed variant (Dunvargan-GL) identified in depressional areas. These soils have low wind erosion risk and moderate water erosion risk; no sensitive soils were observed within the Project area during the field investigation.

For Dunvargan soil series, Ap and Ah horizon (topsoil) depths are on average 25 cm and include well drained loam to clay loam soils and average subsoil thickness was 20 cm. SLR recorded average topsoil thickness in the wetland areas as 30 cm and average subsoil thickness as 20 cm.

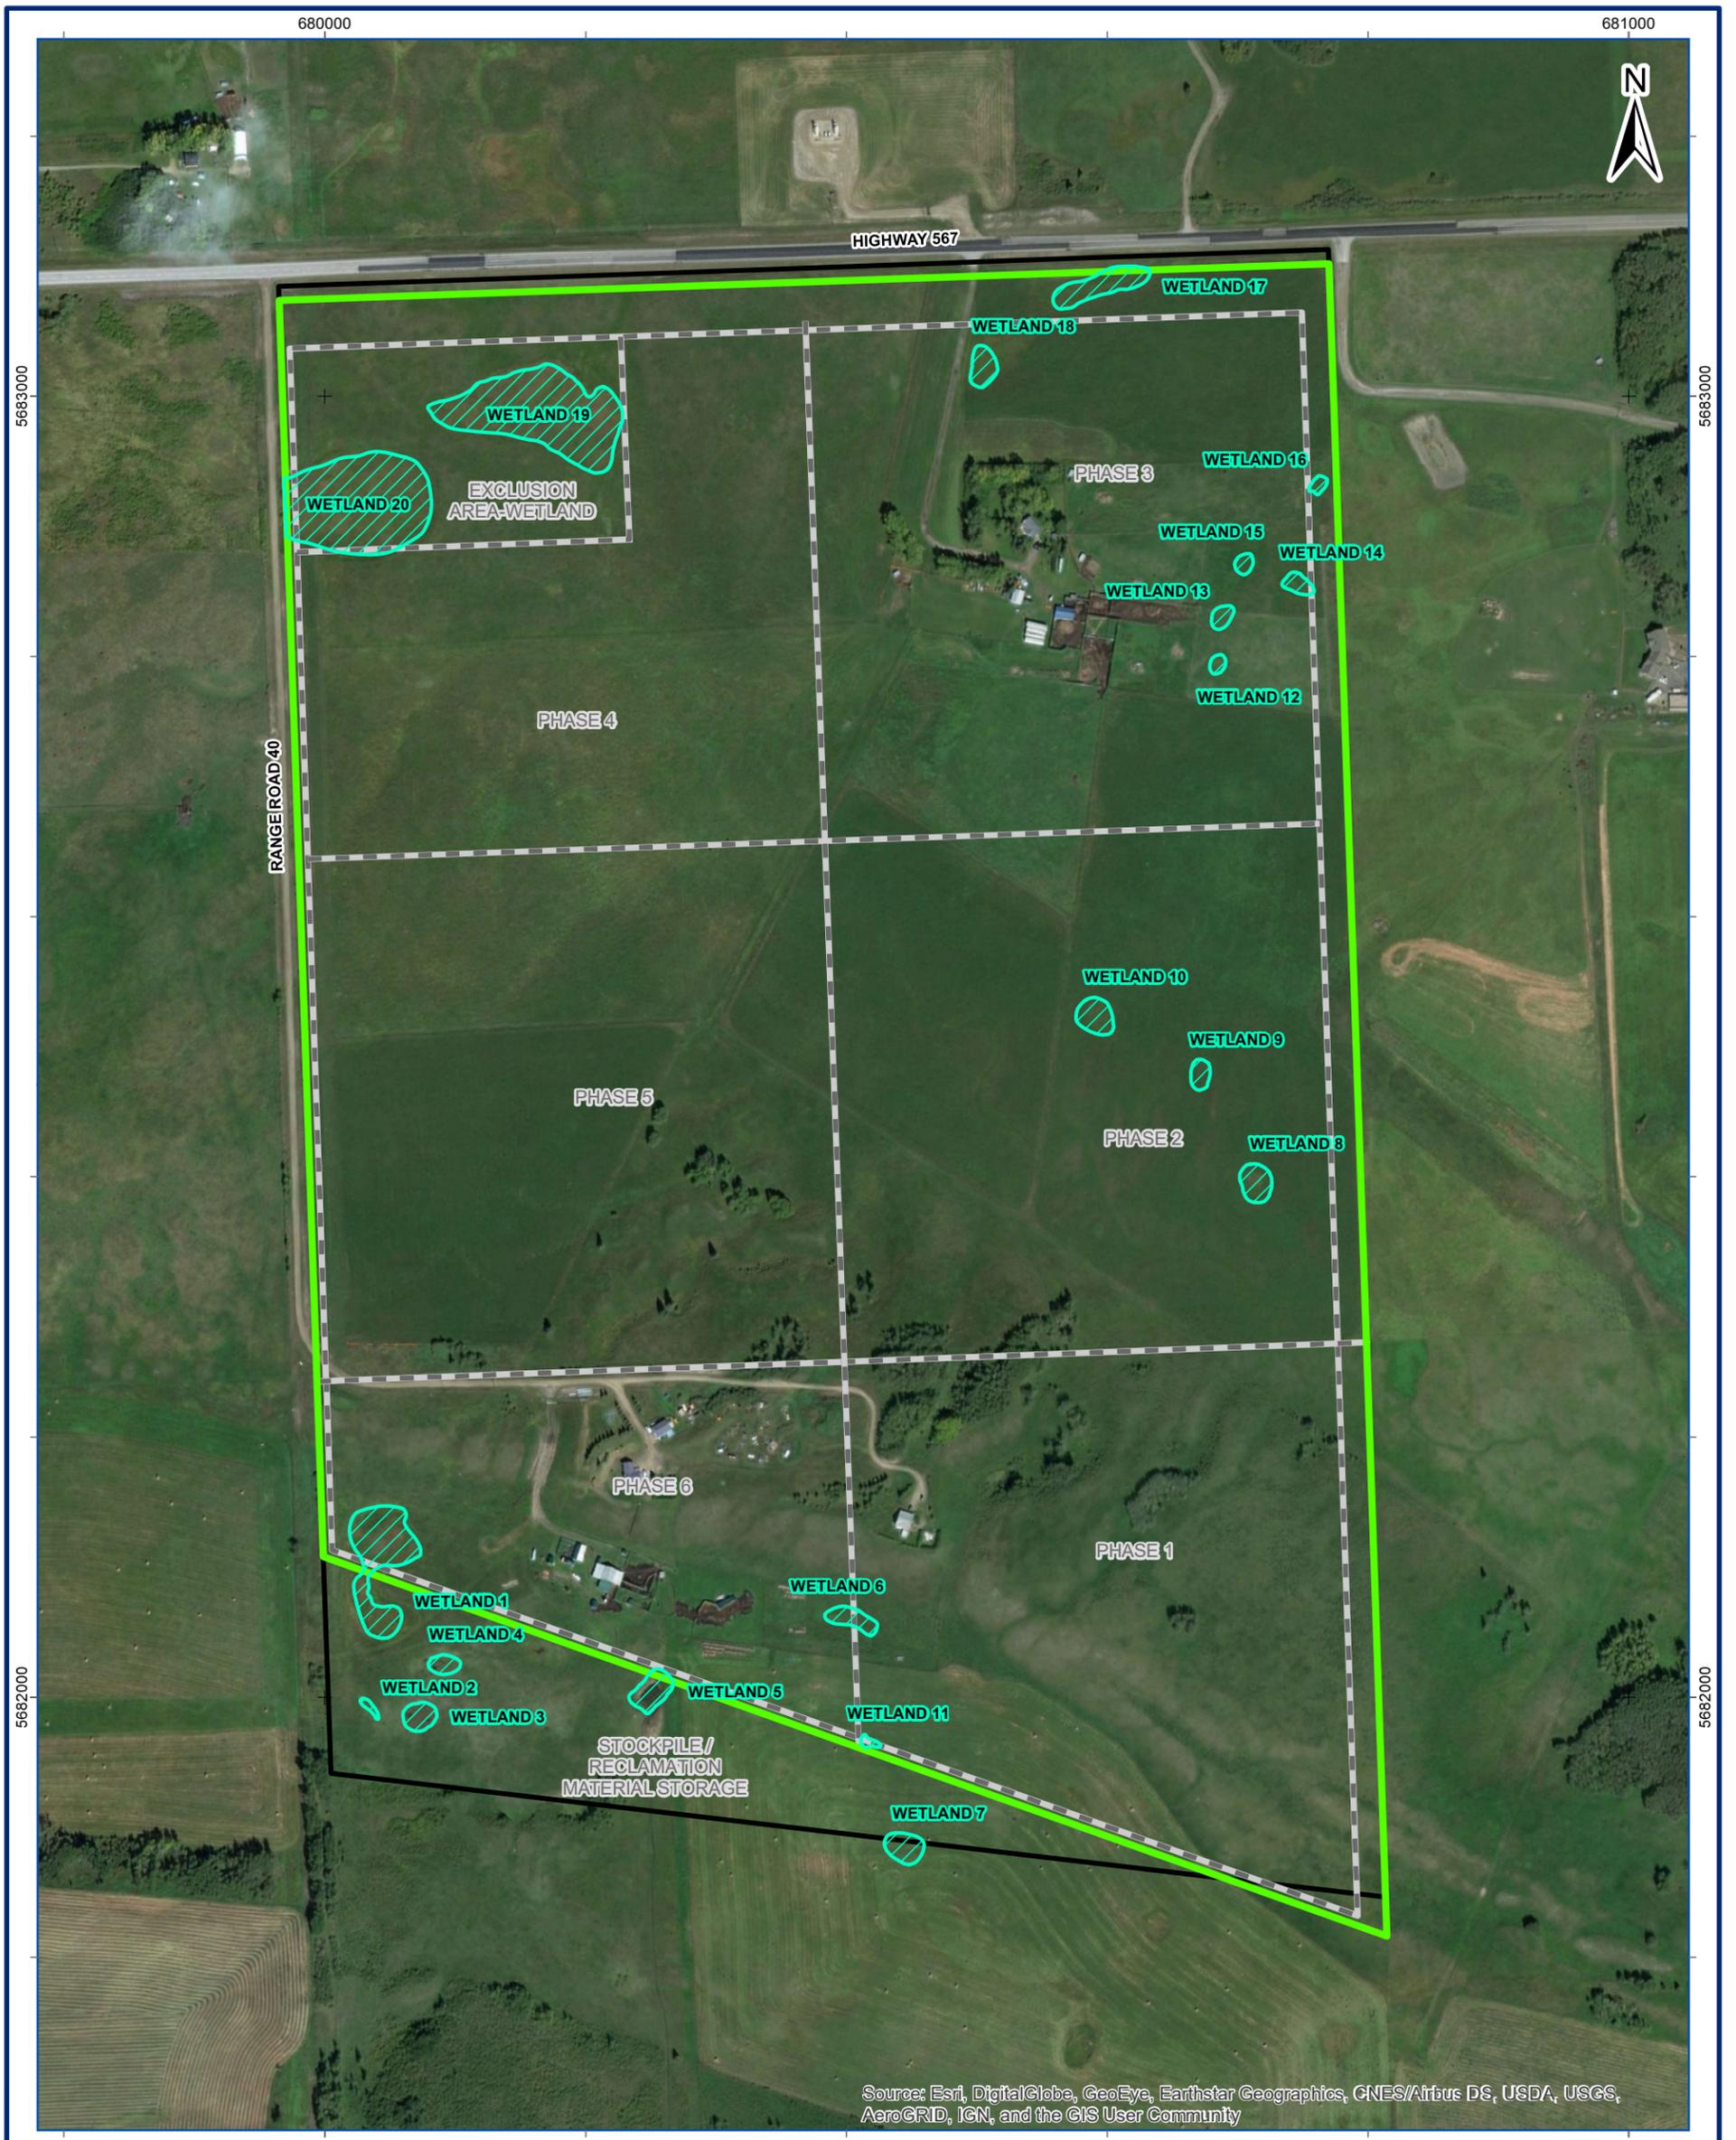
**IDENTIFIED WETLANDS**

Ten wetlands ranging from class 1 to class 3 were identified (Figure 3). Detailed information on wetland assessment, including Classification and Species List is provided in Appendix C and D of the Biophysical Impact Assessment Report.
